# Steering Box Rebuild:

## Introduction:

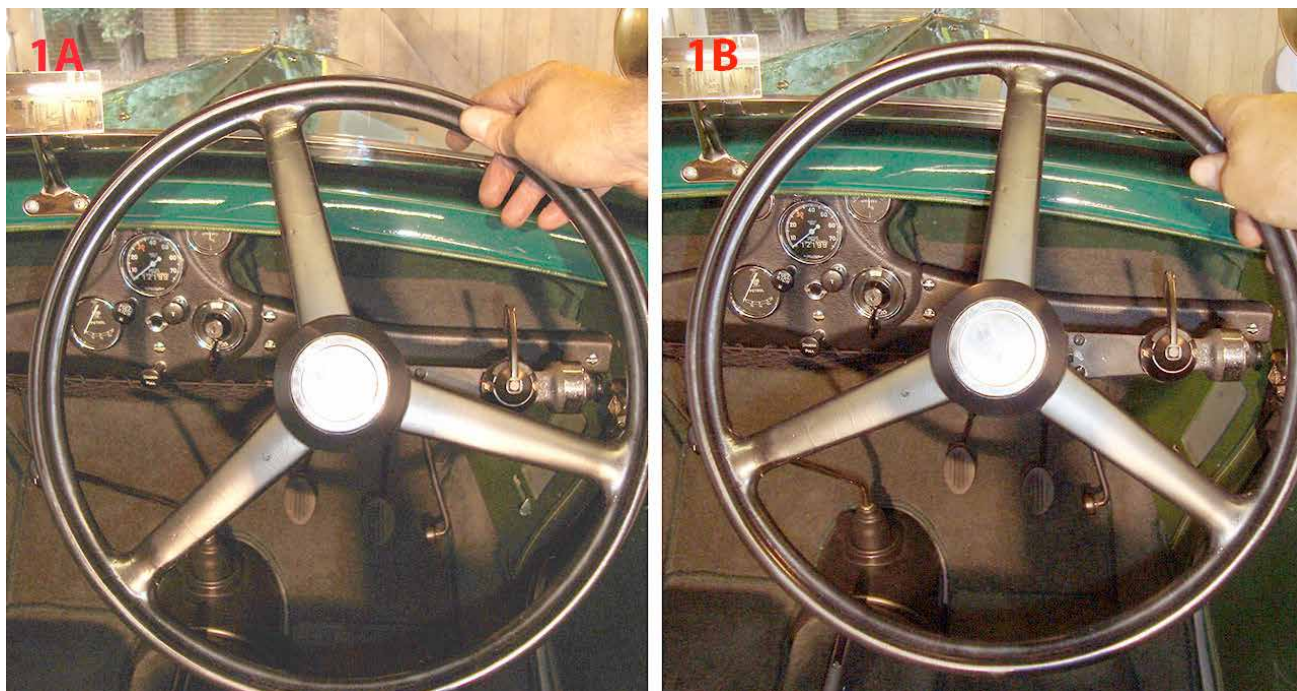
When looking under the car one could also see the play on the drop arm, and the steering wheel had about 3 inches of play before engaging. Sadly my photographs do not follow the following narrative 100% at every stage, I took as many pictures as I could and ended up covering wife's camera in black grease; its light grey strap was black at the end of the day—dog-house for me... but what's new?

*Picture 1: Shows the play in the steering wheel prior to starting.*

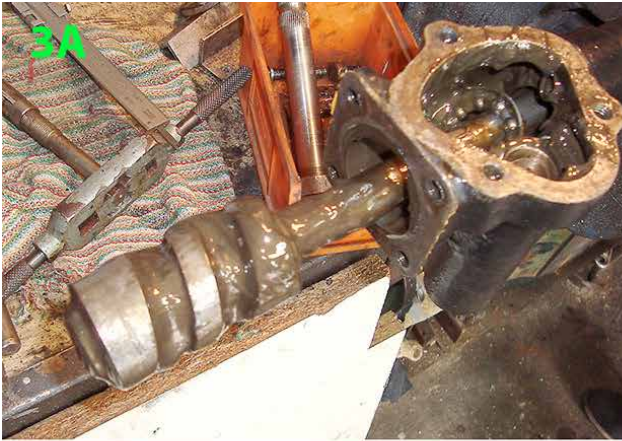
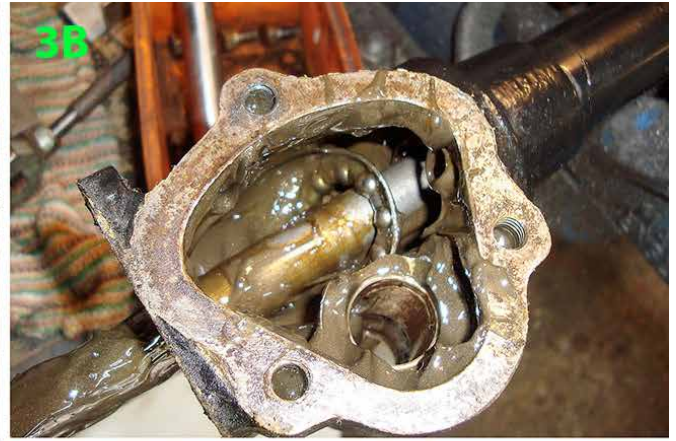
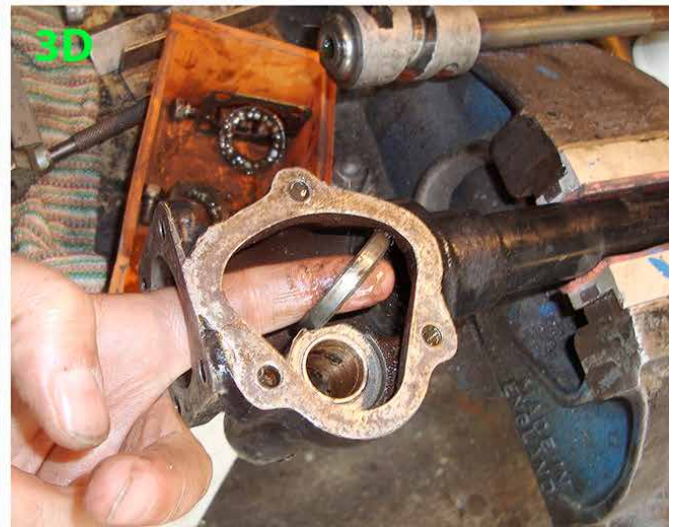
After removal of the above, the bottom bearing race and bearings came out easily, allowing the inner steering column with worm gear to be pulled right through and out. This left the top bearing loose on the inner steering column, easily removed when the inner column was completely extracted from the outer column. This just left the top bearing race to be removed from the back of the box housing, which was done with the persuasion of a screwdriver down through the top plate opening.

Picture 3: Shows these steps.

Following all of the above, the now empty steering box and column, inner column and worm, top and bottom plate all had a thorough clean in thinners to remove all muck, dirt and grease. Box stripped and cleaned, quick and simple. Inspection of the worm showed it was in good condition and only needed a light cleaning with a carborundum stone.

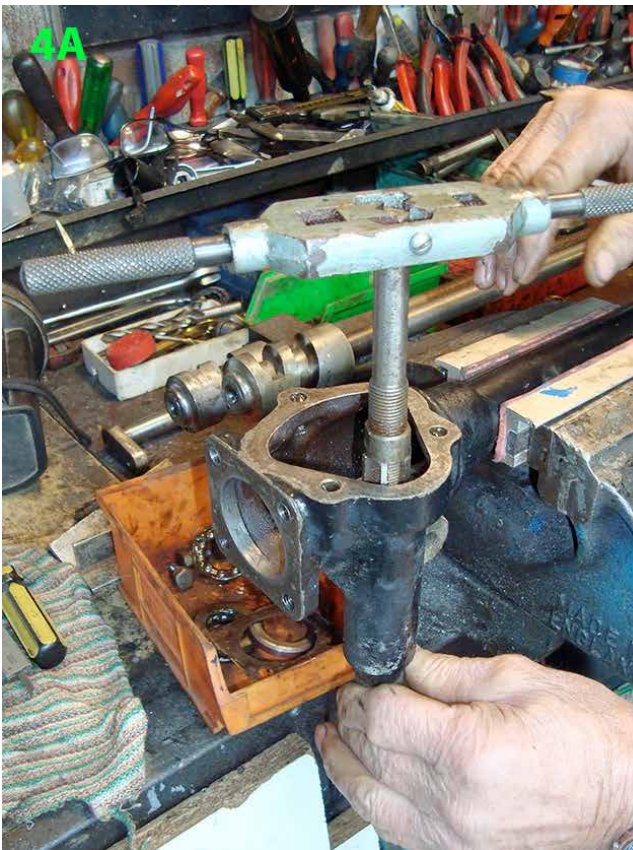
Once clean, it was fortunate to find that my box had been fitted with bushes for the sector shaft, which had obviously been replaced at some time. These bushes had sufficient material left to allow them to be re-reamed to take my new oversized sector shaft; saving the effort of having to drift out old bushes or machine and fit a new set. However, next came a very long but valuable lesson on using an adjustable reamer.

*Picture 4: Shows centring the reamer with a tapered collar underneath, followed by reaming bottom bush.*

My new sector shaft was 0.020" oversized; so the bushes needed reaming. Bit by bit, very slowly the top bush was reamed till the new sector shaft could be fitted snugly. This took me 90 minutes and about 30-plus incremental passes, but better to ream slowly and check each and every time than cut too much, then have to fit new bushes and start all over again. Once one bush was done the box was turned over and the bottom bush could be reamed in the same way, but slightly quicker, by backing off the reamer for the first cut, knowing with confidence it would be smaller than needed for the first cut/pass.

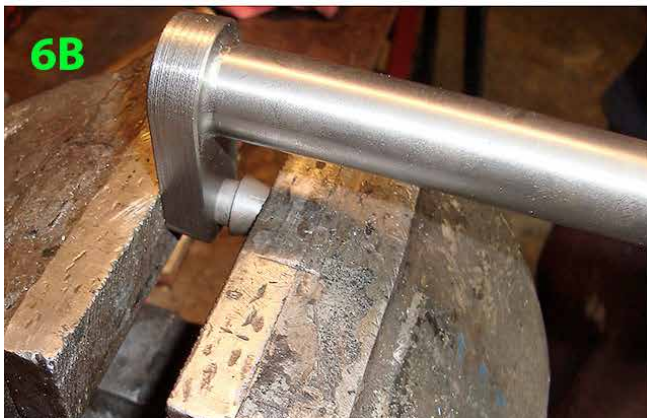
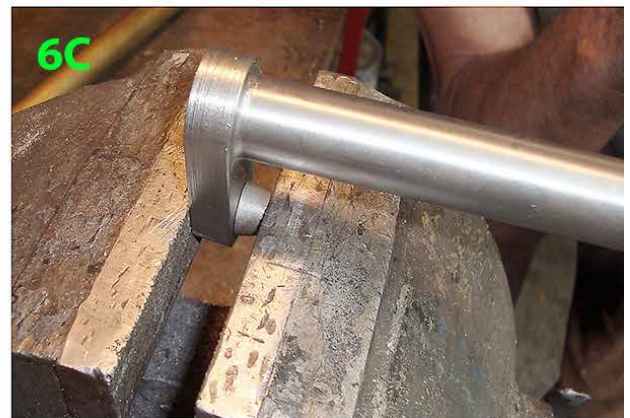
Picture 6: Shows the removal of the sector shaft once more, and the worm peg being pressed in using the jaws of a vice—quick and simple.

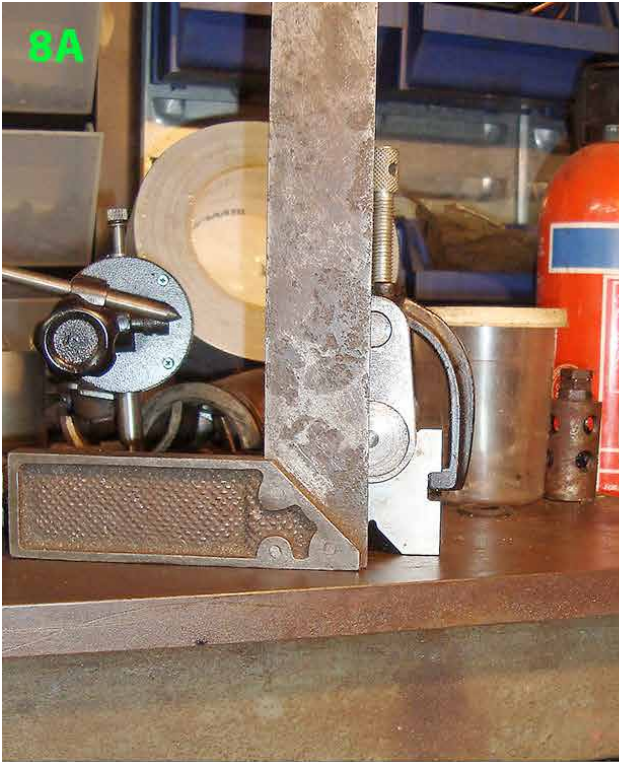
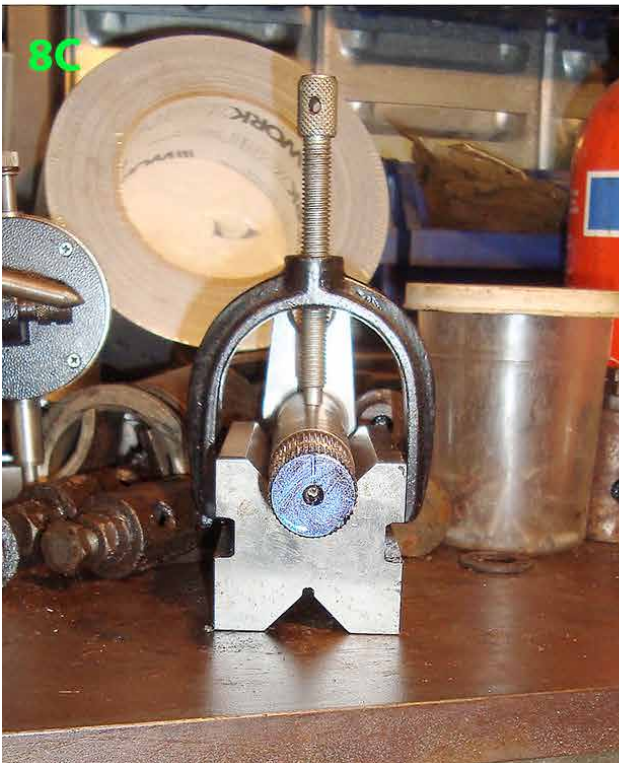
A new centreline was also needed on the other end of the new sector shaft to align with the centreline on the drop arm to ensure the arm is fitted in the correct position. On an engineer's plate, using engineer's blue on the end of the shaft; clamping the shaft in small bench jaws; ensuring by eye it was vertically aligned and using a steel right angle, the centre line was scribed.

Picture 8: Shows these steps and a final permanent marking with a cold chisel.

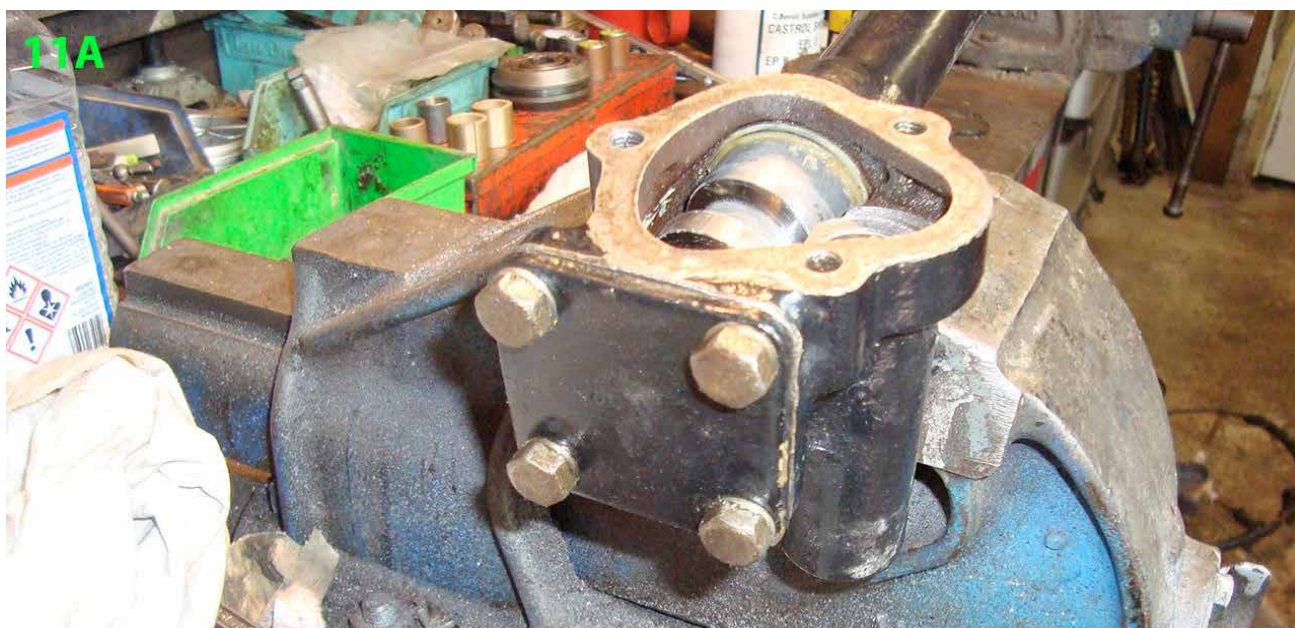
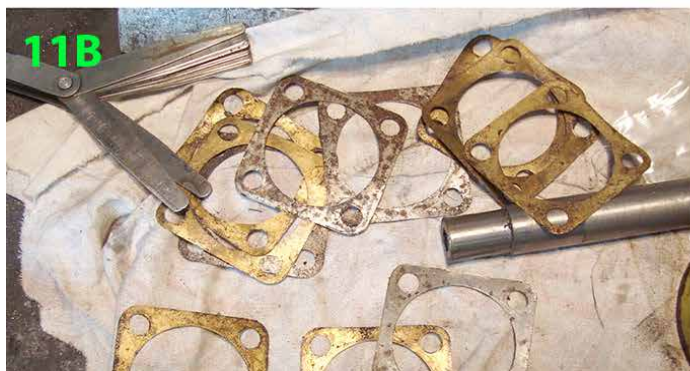
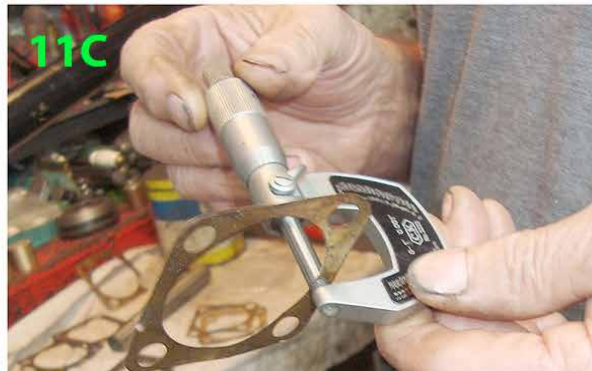
Next was tightening and adjusting the bearings and setting the number of shims correctly, which was time consuming. After fitting the steering wheel at the top of the column, the bottom bearing plate was offered up and all 4 bolts fitted and nipped up in place without any shims. It was tightened evenly until a small amount of drag was felt when turning the inner column with the steering wheel. Once a small amount of drag could be felt, the gap between the bottom plate and the box itself without any shims was measured with a set of feeler gauges. At first measurement I estimated the gap was about 0.028". Adding and removing shims and retrying numerous times ended with 6 shims in place amounting closely to the aforementioned gap; tightened until a comfortable amount of drag could be felt when turning the wheel; and obviously zero movement backwards and forwards down through the bearings (tugging backwards and forwards directly through the column on the steering wheel). Removing the bottom plate, adding and removing different sequences of different thickness shims and refitting the plate took about eight attempts to attain the satisfactory drag. I could feel the bearings moving when turning the inner column, without any feel of them grinding. Too tight and you feel them grind; too loose and you cannot feel the drag, and the inner column had vertical movement through the length of the column.

Picture 11: Shows the above shimming, and double checking each shim with a micrometer.

N.B. Keep a notebook to note all the shims' thicknesses and the sequence they are in. This helps when adding and removing and keeping track of the number and their overall thickness; aiding decision-making when adding or removing.

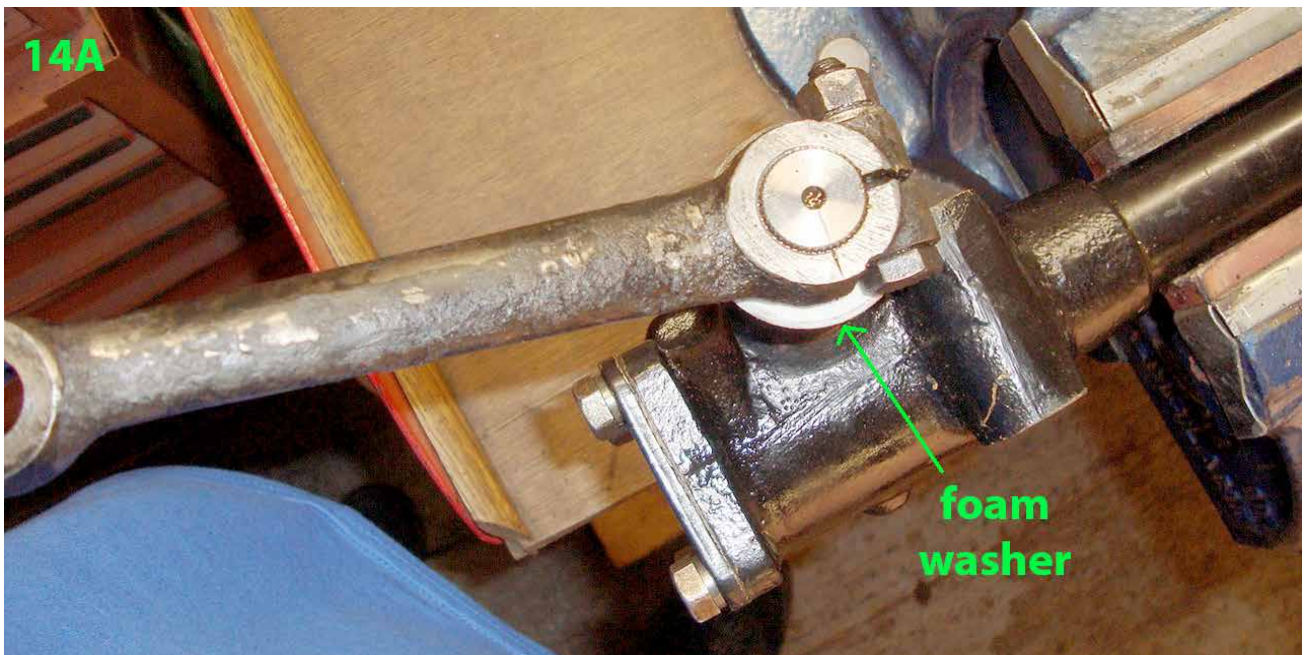
Last of all was to fit the drop arm. Before fitting, I added a small foam washer (taken from the packaging on a stack of recordable CD's) and fitted this over the sector shaft to minimise grease leakage here; I assume originally there may have been a felt washer fitted. The drop arm was then aligned with its marked line to the centre line (added to the sector shaft as mentioned earlier—see pic 8). A snug fit to locate the arm's nut and bolt, but compressing the washer and tapping the nut gently in; and finally firmly tightened up.

Picture 14: Aligning to markings and fitting the drop arm.
